## Hot Springs Canyon Fish and Amphibian Monitoring, 2014

Paul C. Marsh  
Marsh & Associates, LLC  
5016 S. Ash Avenue, Suite 108  
Tempe, Arizona 85282

October 27, 2014

## Summary

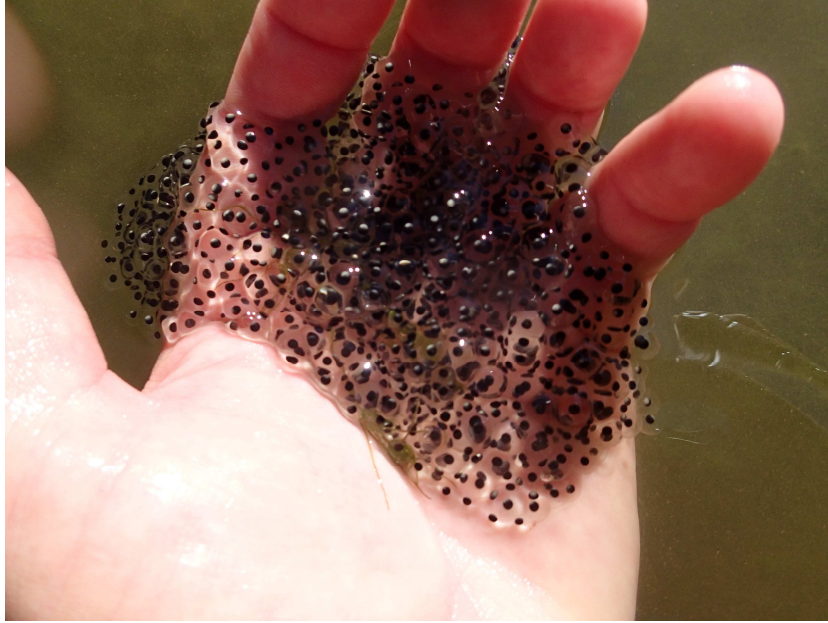
Multiple confirmed adult lowland leopard frog adults were captured or observed; most were seen downstream from the barrier. One frog egg mass (Fig. 1) was found associated with aquatic vegetation at the margin of the plunge pool below the barrier; species could not be reliably determined. No tadpoles were encountered, although this life stage could potentially be present at this time of year (Brennan and Holycross 2006). A single non-native bullfrog carcass (desiccated) was observed below the barrier but no live individuals were encountered. Several live bullfrog adults were observed near the barrier site during 2013 monitoring for the first time (Marsh and Marsh 2013).

Fig. 1. Hot Springs Canyon, Cochise Co., Arizona. Amphibian egg mass found associated with aquatic vegetation in the plunge pool below the constructed fish barrier; October 16, 2014.

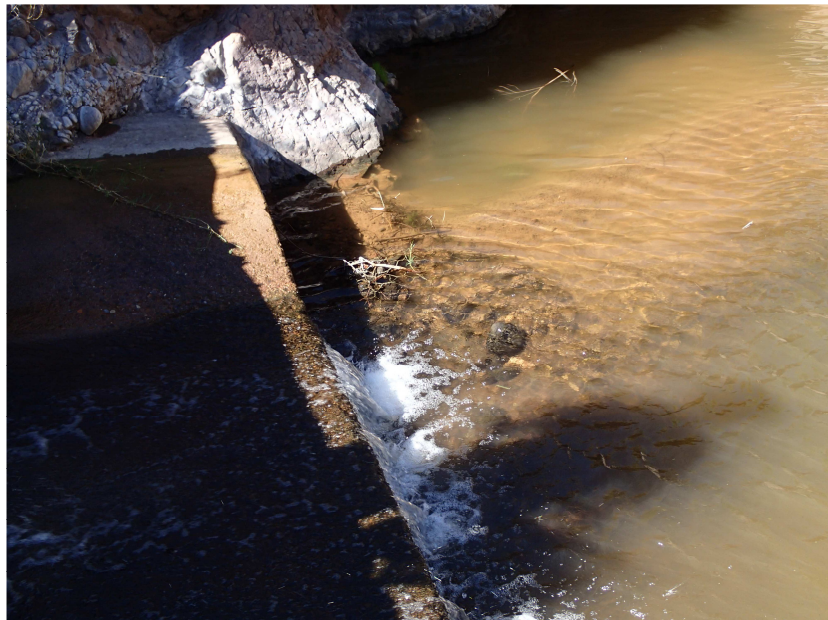
The barrier structure was carefully inspected and photographed. Wire gabion on both sides immediately downstream of the apron was exposed (e.g., Fig. 2); this condition is unchanged from previous visits. The structure itself appeared intact and there was no evidence of cracking or other failure, or of erosion of material. However, access around the barrier now requires difficult scaling of the near-vertical adjacent bedrock walls or wading/swimming through the deep scour hole below the barrier. This is because the channel bed has been lowered by removal of stream sediments across the entire stream width between the walls immediately downstream of the barrier apron.

Fig. 2. Hot Springs Canyon, Cochise Co., Arizona, showing exposed wire gabion at the base of the constructed fish barrier apron on river left; October 16, 2014.
